Increasing the Power of the Turbogenerator in the Process Of Modernization in the Mining and Energy Industry

One of cardinal solutions for turbo-generator renewal and its service life extension consists in modernization of the stator with its rewinding and partial active steel replacement. This modernization was done on the generators type TVV-200-2A in TPP Bitola, and is subject of this paper.

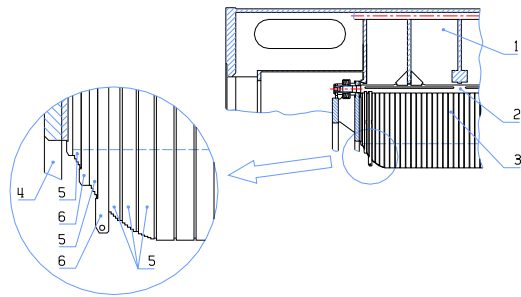
1.stator housing 2.stator rib 3.stator magnetic core 4.pressure ring 5.monolithic stator pack 6.pressure finger

Figure 1. Modernized end part of stator magnetic core for turbo-generator n.1 in TPP Bitola

1. Replacement of five end packs of each active steel end zone, which are manufactured in monolithic (backed) version and with successive reducing of its height from inside towards the ends.

For reducing the looses and heating of the stator core so called “magnetic shunt” is applied. It represents special packs from electro-technical steel, similar to the packs from the basic core, but in length of 36.5 mm first, 31 mm second, 24 mm third, 18 mm forth and 18.5 mm the fift pack from the inside towards the end with hard pressure with fingers. (picture 1) The way they are placed these packs do not change the basic magnetic flow, but they short circuit the axial flows from dispersing on the end parts of stator winding with cutting from

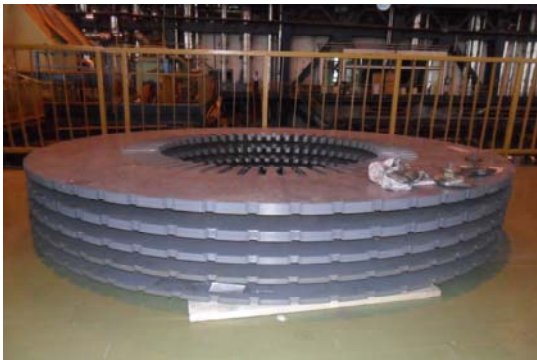
On picture 2 monolithic (backed) packs which were mounted on the end parts of the stator magnetic core of turbo-generator n.1 in TPP Bitola are presented. As it can be seen packs are reducing in diameter going from the inside towards the end of the core but they are also reducing in thickness in the same direction.

Figure 2. Monolithic packs for replacement of the end part of stator magnetic core for turbogenerator n.1 in TPP Bitola

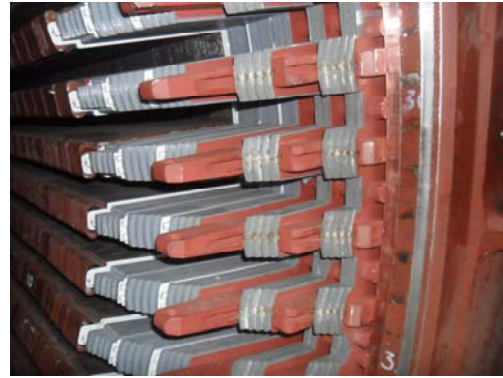
On picture 3 modernized end part of the magnetic stator core of turbo-generator n.1 in TPP Bitola is presented.

Figure 3. Modernized end part of the magnetic stator core of turbo-generator n.1 in TPP Bitola

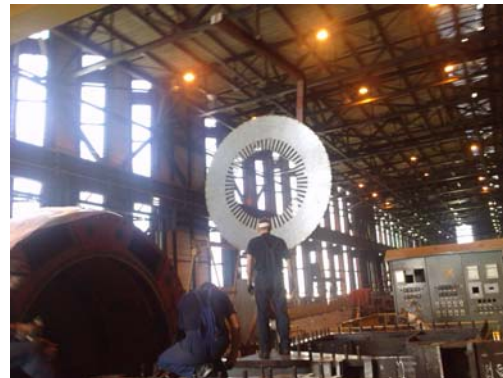
Figure 4. Monolithic end pack of the stator magnetic core in the process of mounting for turbo-generator n.1 in TPP Bitola

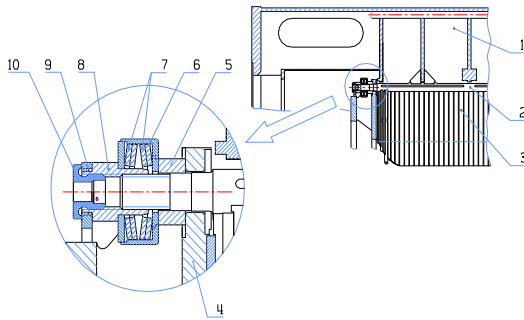
- 1.stator housing 2.stator rib 3.stator magnetic core
- 4.pressure ring 5.fixing pad 6.housing
- 7.spring 8.nut 9.brake 10.screw

In the process of the turbo-generator operation the core tightness may loosen as a result of working influences on the active steel end zone (i.e. temperature, vibration)

Figure 5. Spring blocks which are used for pressure on the stator magnetic core, so called pressure accumulators

The efficient method of restoring the active steel tightening force at the first and the second loosening stages is the installation of special spring devices having the specified and

The spring blocks (pressure accumulators all together 20 from each side of the core) are mounted after carrying out the works on the teeth local repairs and additional works ensuring the core pressure rings movability.

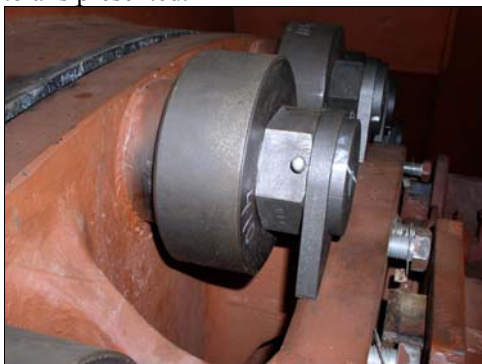
On picture 6 one pressure accumulator which has been mounted on turbo-generator n.1 in TPP Bitola is presented.

Figure 6. Pressure accumulator mounted on turbogenerator n.1 in TPP Bitola
