Increasing the Power of the Turbogenerator in the Process Of Modernization in the Mining and Energy Industry

One of cardinal solutions for turbo-generator renewal and its service life extension consists in modernization of the stator with its rewinding and partial active steel replacement. This modernization was done on the generators type TVV-200-2A in TPP Bitola, and is subject of this paper.

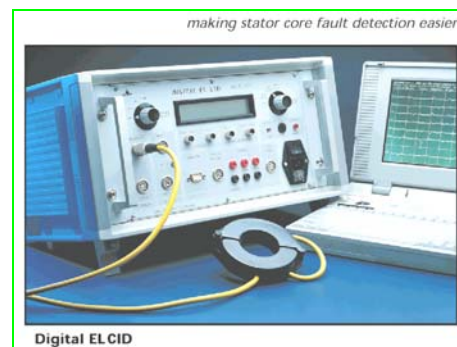
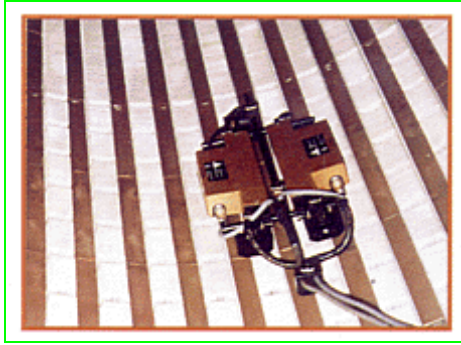
1. Check of core linear dimensions
 - a) Core dimensions before disassembly
 - b) Thickness of the newly installed packs, Exciter side
 - c) Thickness of the newly installed packs, Turbine side
 - d) Core dimensions in pressed condition
2. Electromagnetic inspection of active iron lamination faults by using automatic inter-lamination fault monitoring system (ELCID) according to standard IEEE 62.2-2004 in which current bigger than 100mA while induction in yoke is 4% from nominal one, indicates isolation disturbance

Figure 7. Instrument ELCID and probes in process of electromagnetic control of stator core

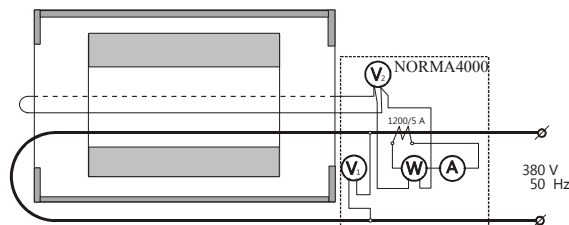
- Biggest allowed core teeth heating 25⁰C
- Biggest allowed difference of heating the teeth compared to core 15⁰C
- Specific losses when induction is 1.4T should not be bigger than 2.2 W/Kg

Figure 8. Connection scheme for core ring flux test

The examinations were carried out with current of 400A, 50Hz from 0.4kV source with one magnetization winding around the core, one control winding and induction of 1T in duration 72 min. according to the following scheme.

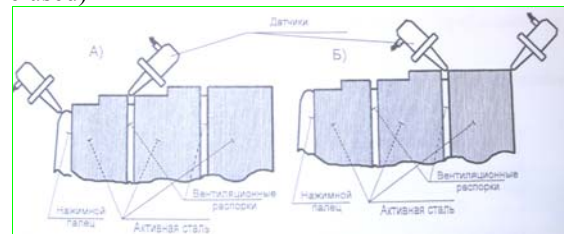
- Good condition of the teeth: less than 0.8 for backed 1.5 for ordinary
- Satisfactory condition of the teeth: 0.8-1.2 for backed, 1.5-2 for ordinary
- Initiation of loosening the tightening force: 1.2-1.8 for backed 2-2.5 for ordinary
- Loosened tightness: bigger than 1.8 for backed and 2.5 for ordinary

Figure 9. Handling the probes for measurement of:

- A) pressure finger – pack
- B) pack from tooth
